# WINNIPESAUKEAN

FALL 2023

## PAUGUS BAY WATERSHED ASSESSMENT

# LANGLEY BROOK HYDROLOGIC STUDY

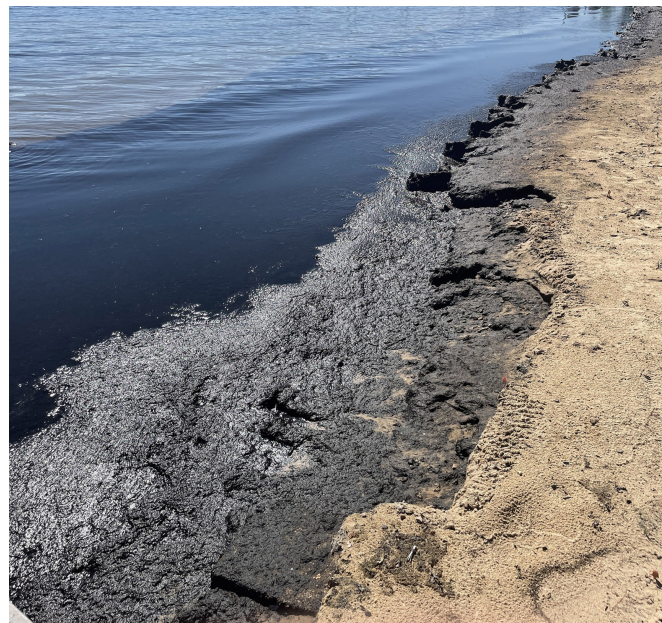
Photo: Stigonematales on the shoreline

Last summer saw the occurrence of stigonematales, a benthic (occurring on the bottom) cyanobacteria on the southwestern shore of Paugus Bay, which persisted for 3 weeks. Algal blooms have also been observed in the Weirs channel, and in Langley Cove.

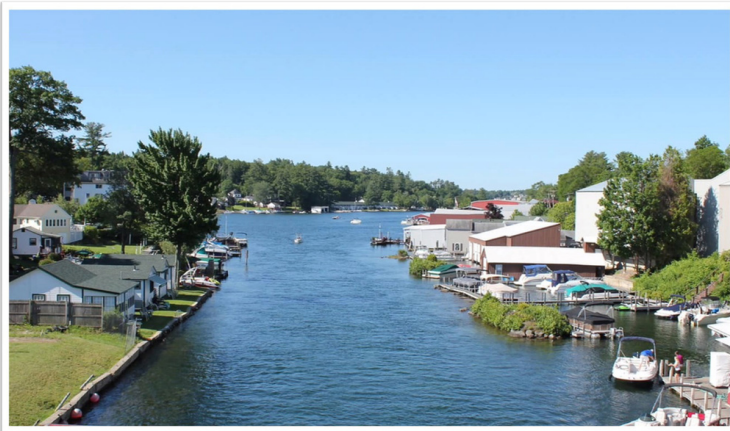
**Paugus Bay, circa 2015**

Research has shown that developed areas contribute 5-10 times the amount of polluted stormwater runoff than forested areas. This excess stormwater runoff causes water pollution, erosion, and flooding. The two images of Paugus Bay from 1906 and 2015 illustrate the change in the landscape from forested to developed land, and how much more impervious area is present.

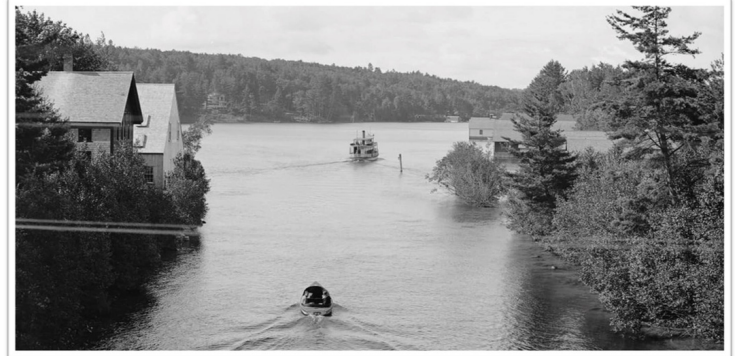
**Paugus Bay, circa 1906**

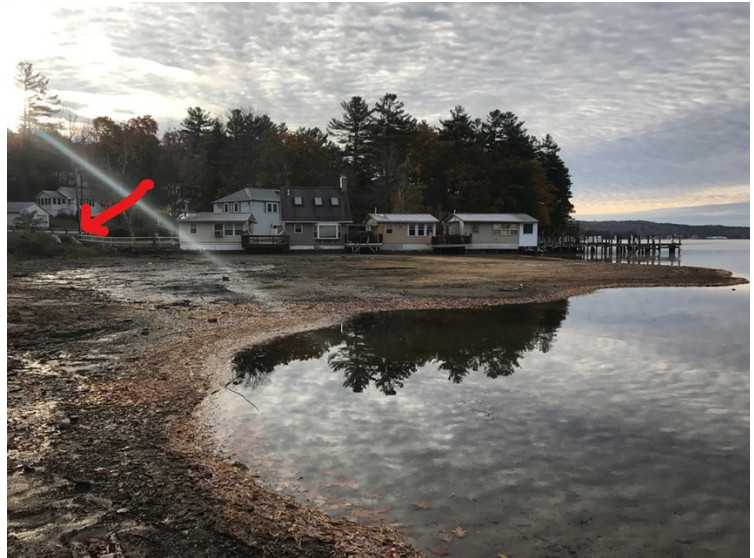
**Langley Cove looking south toward Capri Condos. Red arrow marks the location where Langley Brook comes in under Weirs Blvd.**

Sediment buildup in the cove has been occurring for a number of years, creating a sandbar and impeding boat access for residents. Sediment transported via Langley Brook can originate from a variety of sources, including disturbed soil from development in the watershed and eroded sediment from the bank of the stream itself during high streamflow events. In the past twenty years, there have been two notable high streamflow events caused by the breaching of a beaver dam located on a tributary to Langley Brook.
