LAKE WINNIPESAUKEE ASSOCIATION

Clear Waters Ahead: Directing Action for the Health of Paugus Bay

Bree Rossiter
Conservation Program Manager
May 2024

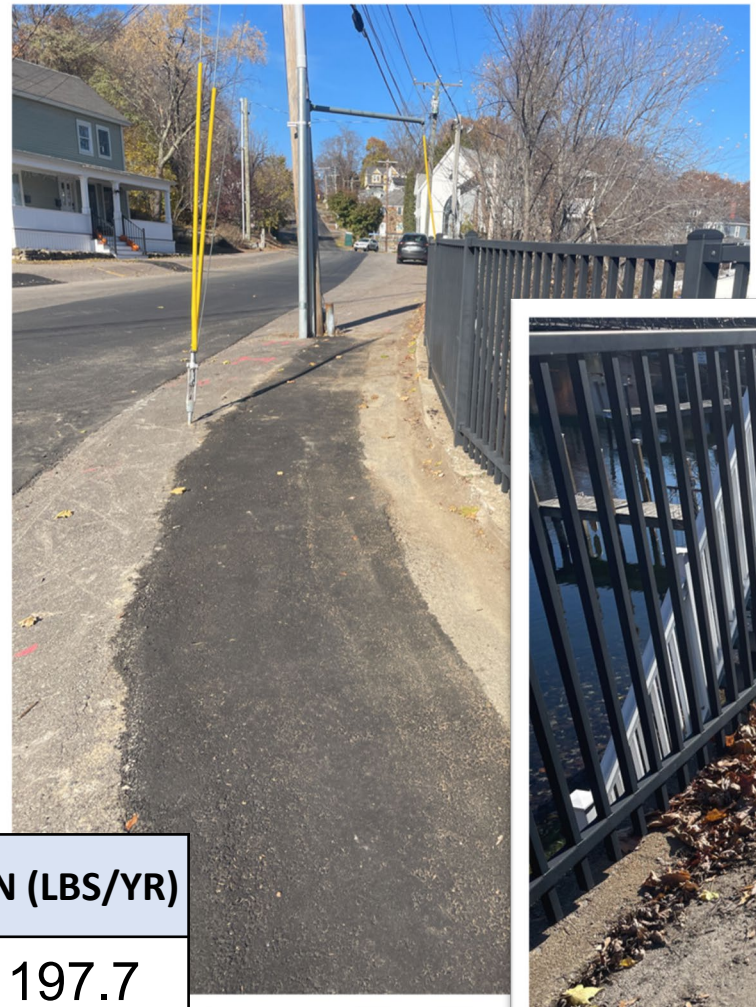
Site ID: PB-P5-01

Impact: High

Observations: Belvidere Rd is a steeply sloping impervious surface that generates and deposits storm water runoff in an area with inadequate drainage less than 20 feet to the Bay.

Recommendations: We recommend installing an underground chamber filtration system to capture sediment and filter out pollutants.

TSS (LBS/YR)	TP (LBS/YR)	TN (LBS/YR)
Pre-Development Nutrient Loads	5427	27	197.7
Post-Development Loads (With BMPs)	543	24	69.2
Reduction Due to BMPs	4885	3	128.5
Difference	90%	10%	65%

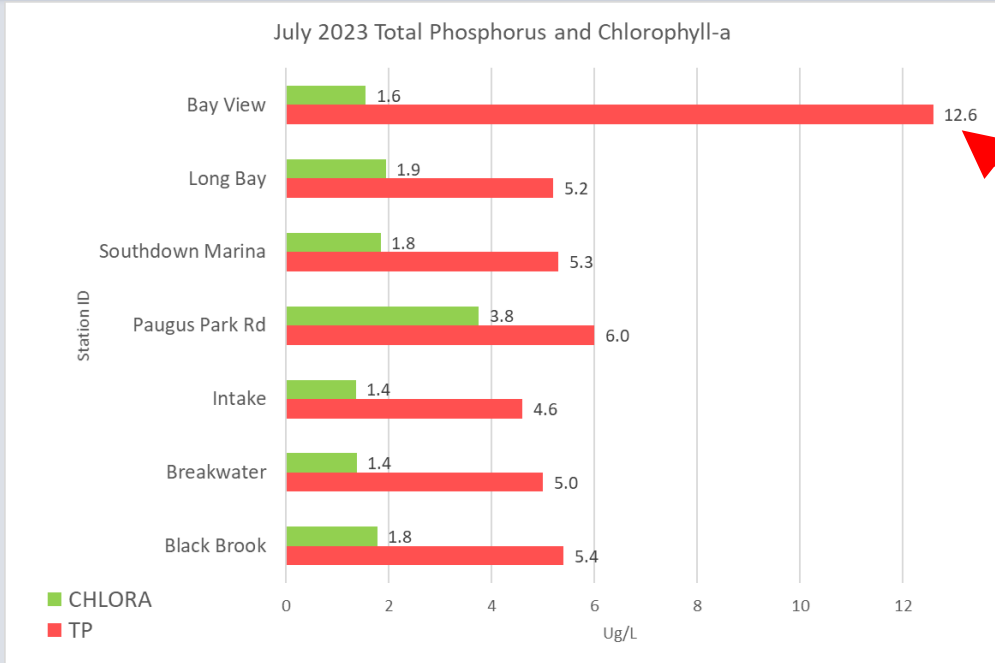
TP and Chl-a levels were significantly higher at Paugus Park Road at almost every sampling event.
